Brenda Natalie Podio

Numerical Analysis of Climatic Conditions
Influence on the Current State of the St. Ann Church

ADVANCED MASTERS IN STRUCTURAL ANALYSIS
OF MONUMENTS AND HISTORICAL CONSTRUCTIONS

Master's Thesis

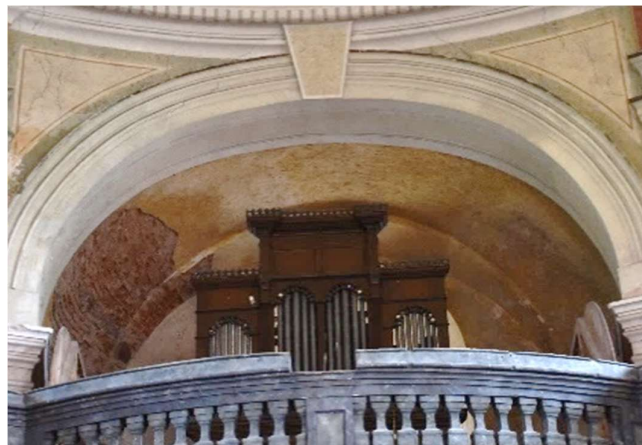
In the interior of the structure it was noticed that beneath the deteriorated render the arches are composed of ceramic brick (Figure 3.8), significantly reducing the dead load and in turn the horizontal thrust from the arches. Although this was only directly observed for the arch under the main entrance, it is inferred to be consistent throughout the remainder of the structure.

Figure 3.8 - Arch at east entrance exposing the brickwork underneath the deteriorated render

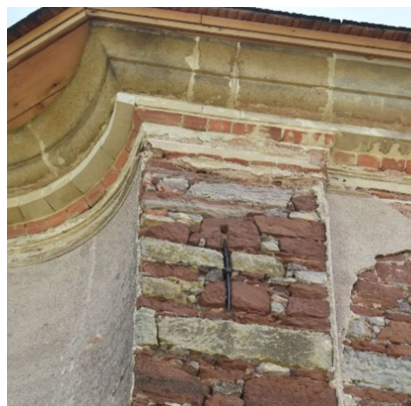
A few steel ties were seen in the masonry walls, beneath the deteriorated render in the west façade (Figure 3.9, Figure 3.10). The steel ties were only observed in the west façade, since the other façades are still covered in plaster. The ties serve to keep the three leaves of the masonry walls clamped to prevent bulging and detachment.

Figure 3.10 - Steel tie on east façade

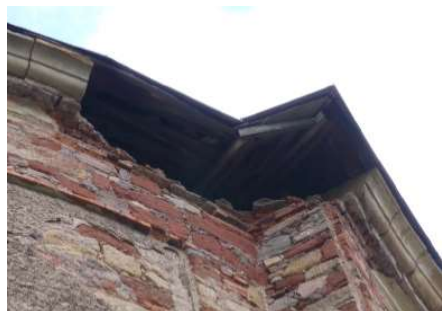
Figure 3.13 - Fallen cornice [10]

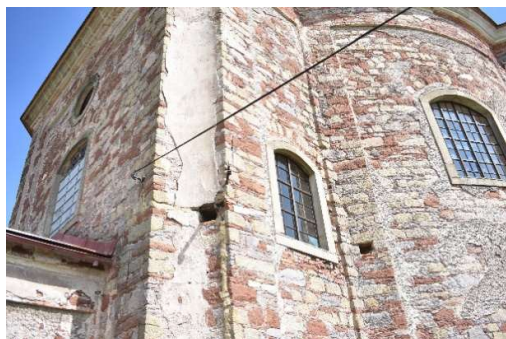
The exterior render presents different rates of degradation. In the north-west, west and south-west oriented walls the render is washed away, popped out or completely delaminated. This results in practically absent plaster and exposed masonry (Figure 3.18). At other areas, the exterior plaster better resisted external actions and deterioration was superficially localized at the junction with the roof or at the bottom 1.5 m of the wall (Figure 3.19). Water penetration and weathering appears to be the main cause of plaster degradation. Freeze-thaw cycles, as well as soluble salt crystallization can generate a change in volume, leading to stone weathering and subsequent plaster bulging and detachment.

Figure 3.18 - Loss of render, south west wall

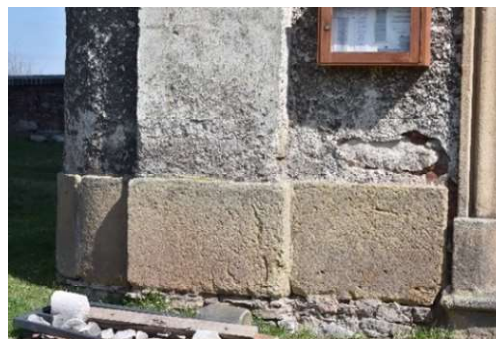
Figure 3.19 - Loss of render, east wall

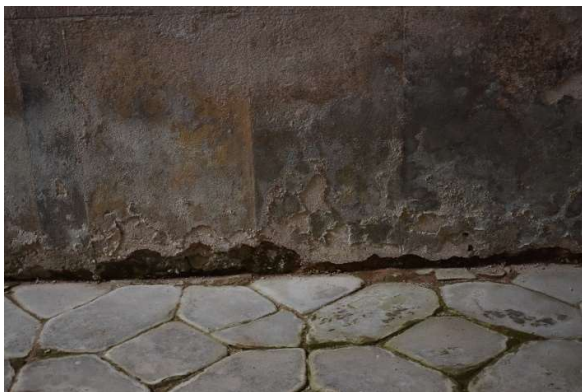
Figure 3.20 – Plaster peeling due to moisture damage, interior north facade

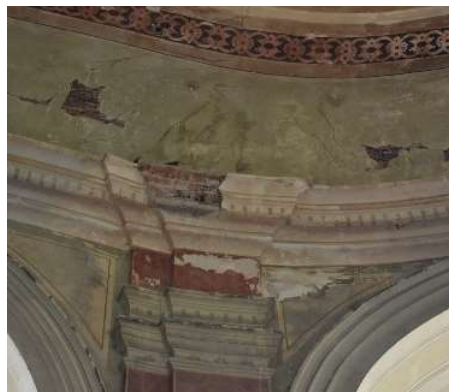
from column capitals and complete plaster delamination from the arch barrel was seen (Figure 3.8, Figure 3.21).

Figure 3.21 - Render loss on column capitals, moisture staining

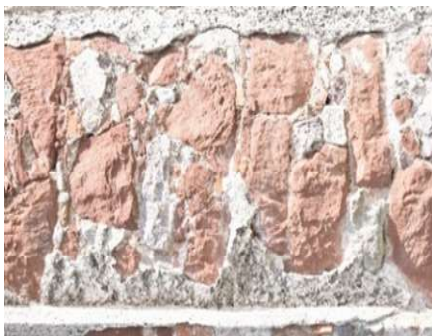
Differential weathering and alveolization can be observed primarily on the exposed red and grey sandstone on the exterior of the building. This is possibly due to inhomogeneities in the stone's chemical or physical properties, as well as the large variability in building stones (Figure 3.22). Differential erosion was commonly seen on most exposed masonry blocks, leading to a loss of the original surface and smoothed shapes. The weathering and erosion of the exposed masonry also led to a significant loss of the lime mortar matrix (Figure 3.23).

Figure 3.22 – Alveolization and erosion

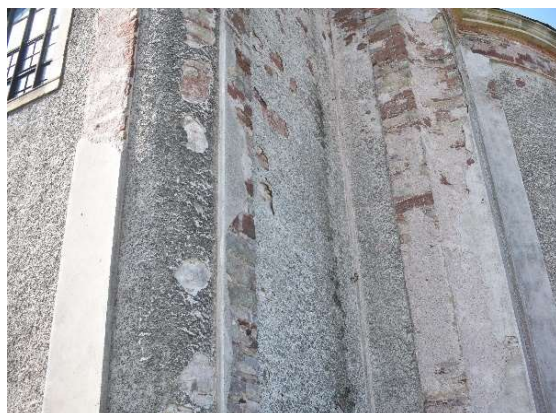
Black crust was most abundant on the front façade of the building and developed on areas that were protected against direct rainfall. The deposit of material resulting in soiling and surface staining that caused a dirty surface appearance was common on the exterior, and was particularly concentrated on the north façade (Figure 3.24, Figure 3.25).

Figure 3.24 – Deposit and soiling, north wall

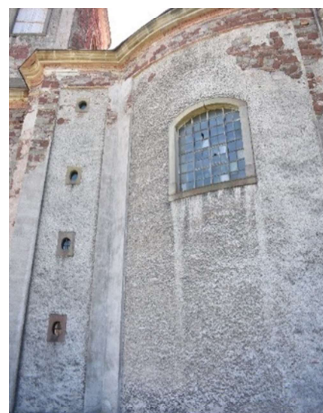
*Figure 3.25 - Deposit and soiling
beneath opening, north wall*

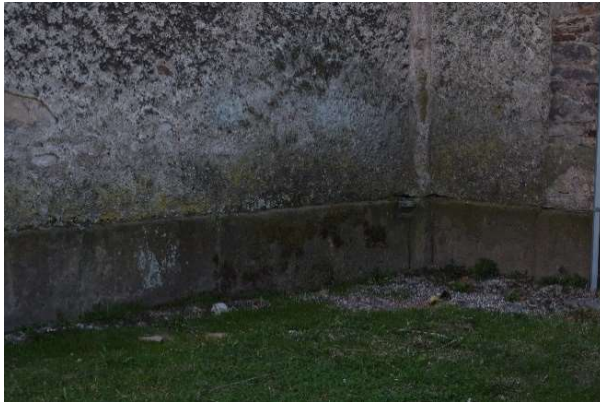
The darkening of surfaces due to moist areas and dampness was seen on both the exterior and interior of the building. The moist areas on the exterior of the structure are limited to the lower course on the north façade (Figure 3.26). On the other hand, the interior walls and floor are highly affected by moisture and have extensive signs of moist area staining and rising damp (Figure 3.27, Figure 3.28). This resulted in heavily damaged plaster with loss of cohesion at the bottom of the wall. The rising damp from the uninsulated foundations, a lack of ventilation and high air humidity are primary causes for the moisture damage in the building interior. More widespread damages were seen on the north and west walls that are not exposed to direct sunlight year-round and thus have wall drying delayed. Moist area staining was also noticed at several spot locations on the ceiling, serving as evidence of previous and ongoing roof leaks (Figure 3.29). It is unclear if the roof leaks are active, as the roof was previously repaired.

Figure 3.26 - Moist area on exterior north façade

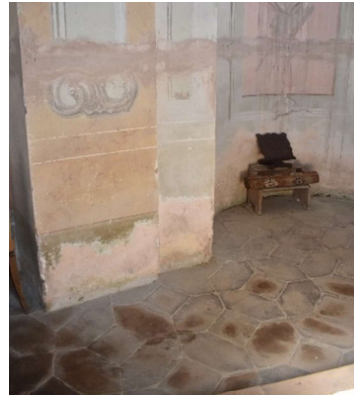
Figure 3.27 – Moisture stains on interior walls, floor dampness

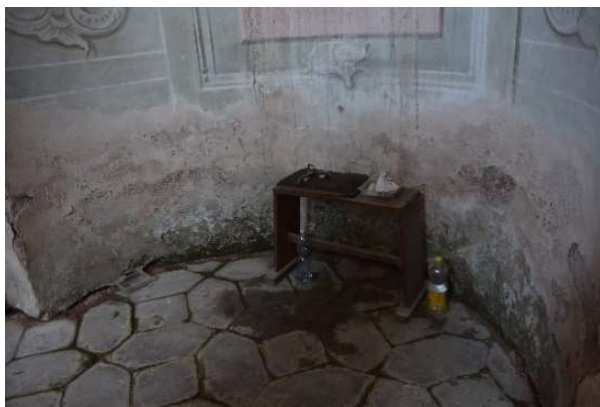
Figure 3.28 – Moisture damage on interior walls, floor dampness

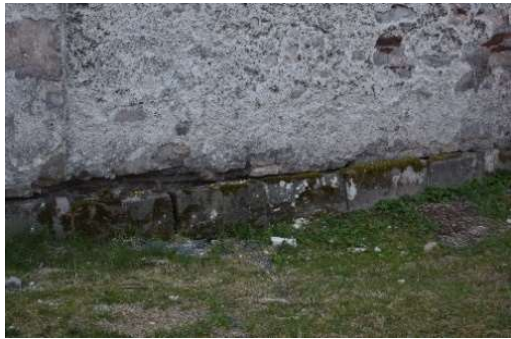
Biological growth was observed in the form of algae and lichens at the bottom of the walls throughout the church walls. At the exterior of the church, lichens and plants were seen on the bottom course of the north façade concentrated in the region where the detachment of foundation stone was found (Figure 3.30). In the church interior, biological growth on the south and north walls are limited to patches of algae, with few larger patches of algae and moss growth spread in the lower 1m portion of walls where the action of rising damp and high moisture was noticed (Figure 3.31).

Figure 3.30 - Biological growth on exterior, north

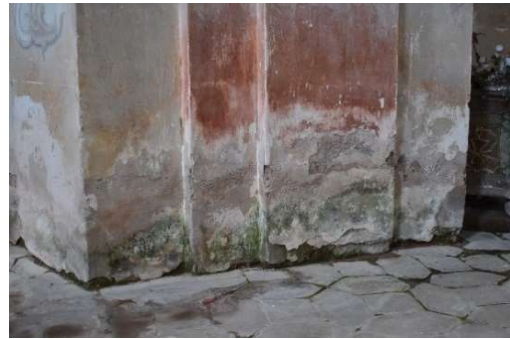
Figure 3.31 - Biological growth on interior, north

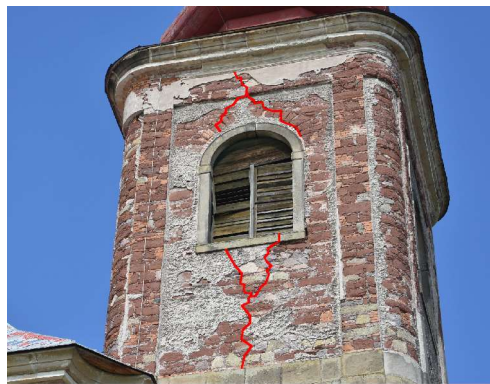
A series of cracks surrounding the opening on the south face of the bell tower were seen (Figure 3.32). These cracks could be due to the use of heavy church bells during the operational life of the bell tower.

Figure 3.32 – Cracks surrounding bell tower opening

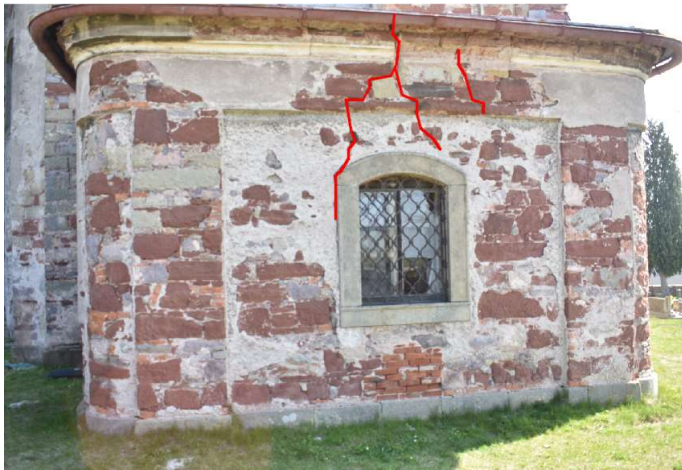
Figure 3.33 - Cracks on sacristy wall above opening

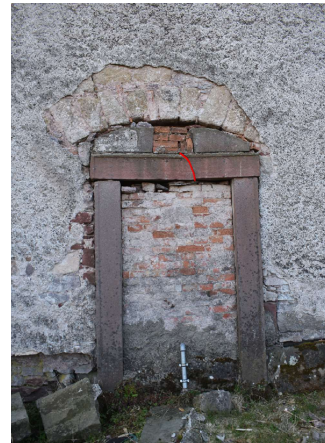
A crack was also observed above the boarded-up door opening on the north wall (Figure 3.34). This crack shows the formation of a false arch in the door lintel, as the lintel was heavily loaded by brick and stone units in a previous alteration. The brick and stone units are completely detached from the arch originally built into the wall, and they appear to pose no further cracking or deformations to the surrounding area.

Figure 3.34 - Crack and stone detachment above opening on north wall

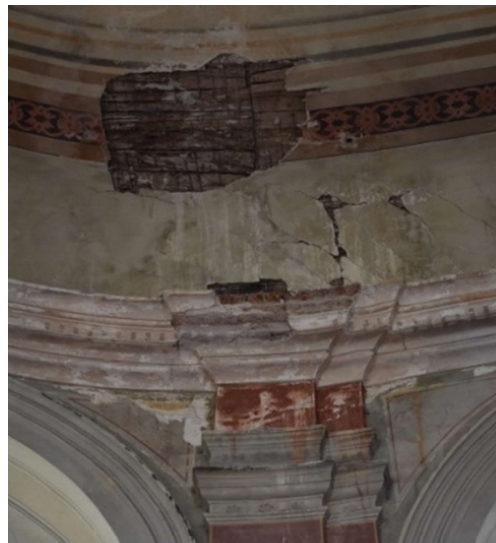
Inside the building, it was common to observe vertical cracks in the plaster at the top of columns and surrounding column capitals as well as in the area above the column capitals in the ceiling render (Figure 3.38). The larger cracks can be evidence of stress concentrations or point loading applied from the roof structure. As well, several of these cracks appear to be aggravated by the delamination of plaster and water ingress from previous roof leaking that can be seen from the stained ceiling and holes in the ceiling exposing the delamination of plaster.

Figure 3.38 - Vertical cracks at column capitals and ceiling plaster detachment

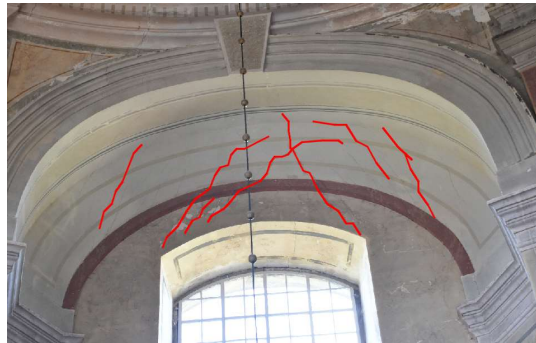
Cracks with varying degrees of thickness and length were seen on the plaster of the transverse section of several arches that are situated above openings. The cracks in the arches were typically small in thickness and ran close to the keystone arch (Figure 3.39).

Figure 3.39 – Transverse crack in arch, north wall

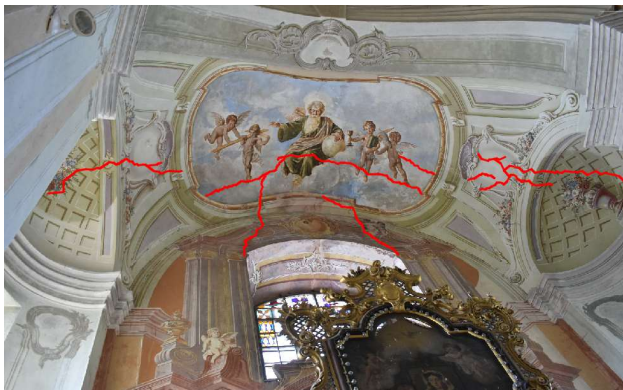
A crack was observed in the longitudinal direction of the arch at the west side of the church, extending to the domes on either side, as well as towards the openings (Figure 3.40). The longitudinal crack extends towards the small domes on either side of the arch and intersects the window frame (Figure 3.41).

*Figure 3.40 - Longitudinal crack in arch barrel,
extending towards opening*

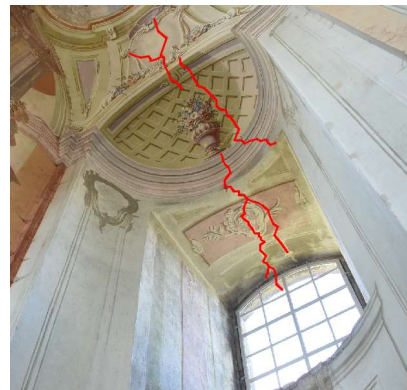
*Figure 3.41 - Extension of
longitudinal crack into openings*

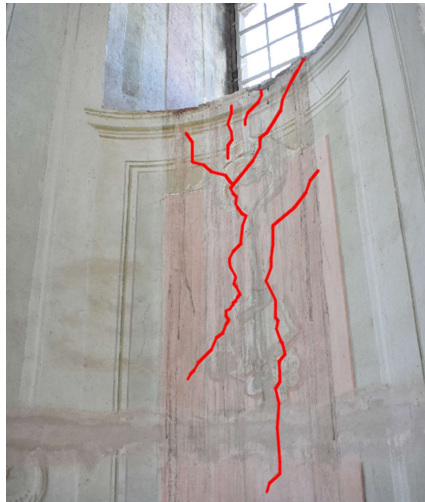
A series of thin vertical cracks can be observed throughout the main nave. Vertical cracks were commonly seen beneath the window openings (Figure 3.42) and in the plaster of walls on the north and south facades below balconies (Figure 3.43).

Figure 3.42 - Cracks below window openings

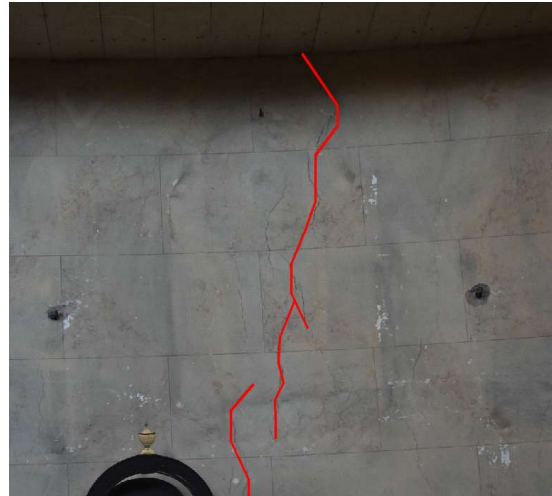
Figure 3.43 - Vertical cracks below balconies

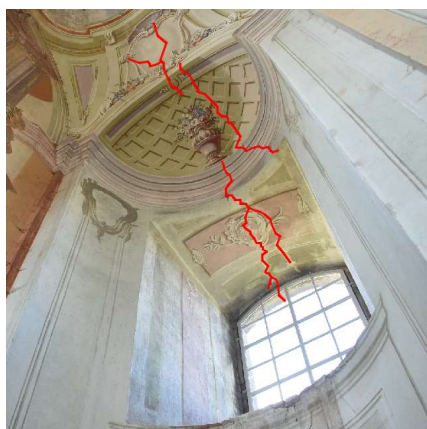
Figure 6.40 - Longitudinal crack in arch barrel, extending towards opening

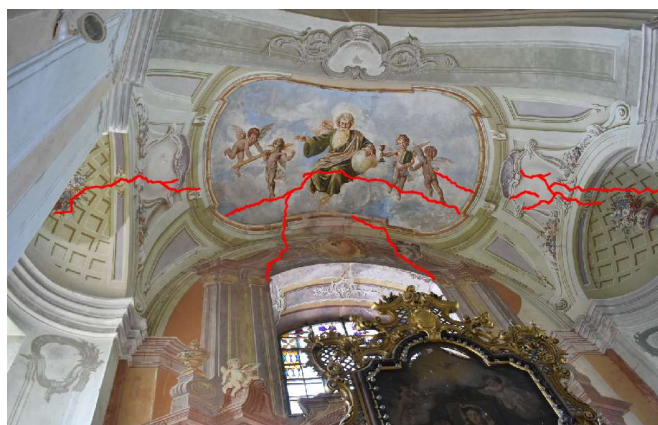
Figure 6.41 - Extension of longitudinal crack into openings

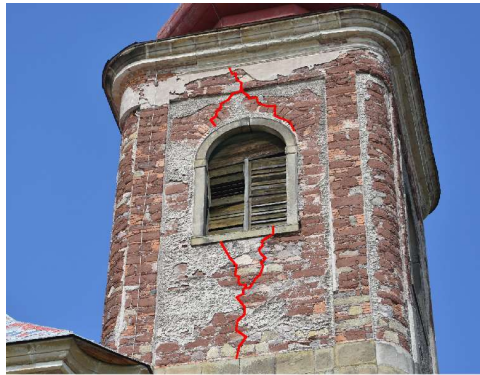
Figure 6.44 - Cracks surrounding bell tower opening

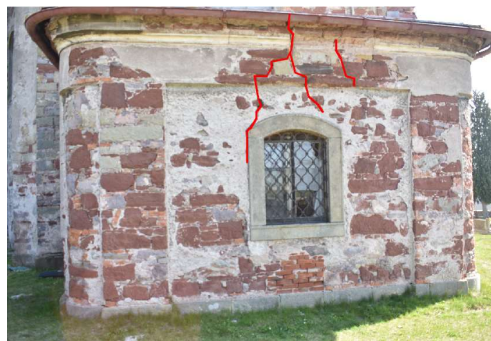
Figure 6.47 - Cracks on sacristy wall above opening
